Carrigtohill Flood Risk Assessment

Main Report (Hydraulics)

Cork County Council

JBA Consulting

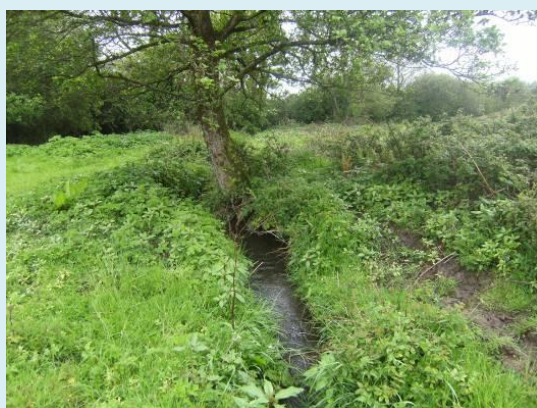
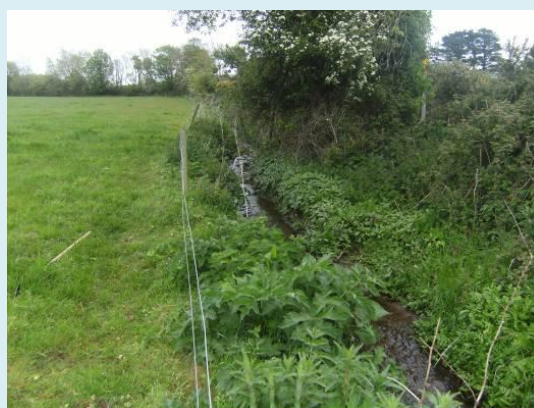
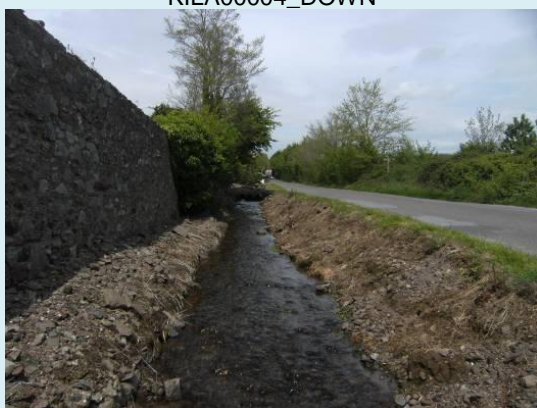
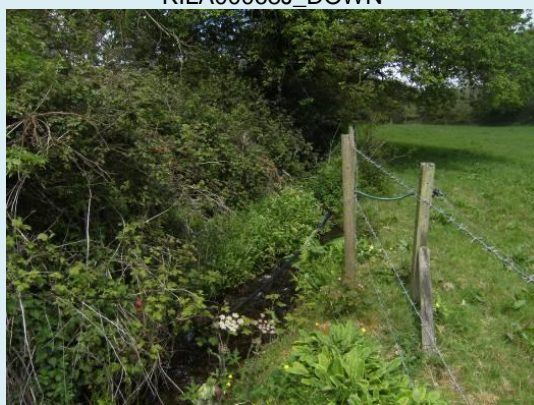
Photo 2-3 Kilacloyne Stream Typical Channel

KILA00004_DOWN

KILA00025_UP

KILA00065I_UP

KILA00068J_DOWN

KILA00077I_UP

KILA00095_UP

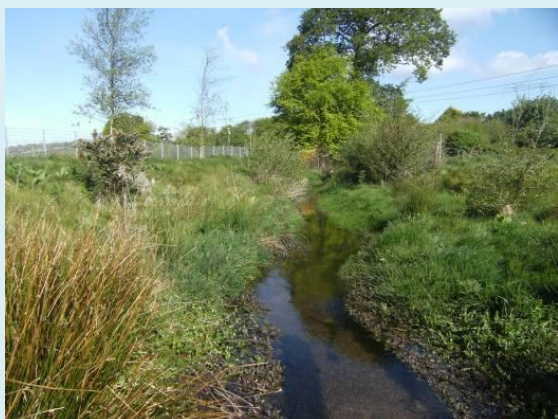
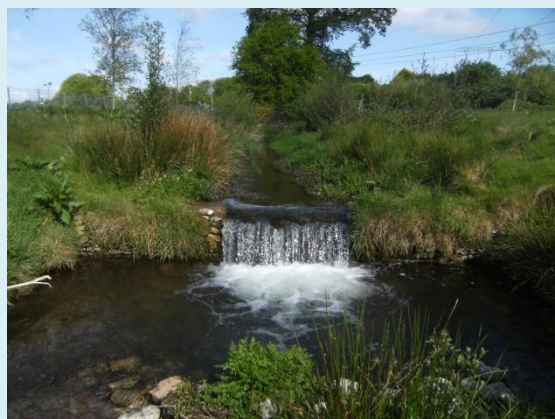
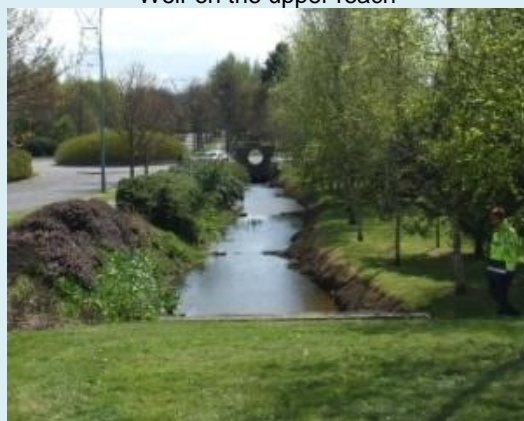
Photo 2-7 Tibbotstown Stream Channel Photos

Upstream channel section

Weir on the upper reach

Pond area upstream of the rail line

Weirs downstream of the rail line

Downstream of the rail line the channel flows through a number of culvert and weir structures, passes under the N25 Road and discharges into Slatty Pond. Photos to illustrate the general character of the watercourse are presented below. More information on the structures and how they have been represented in the hydraulic model can be found in the Model Check File in Appendix D.

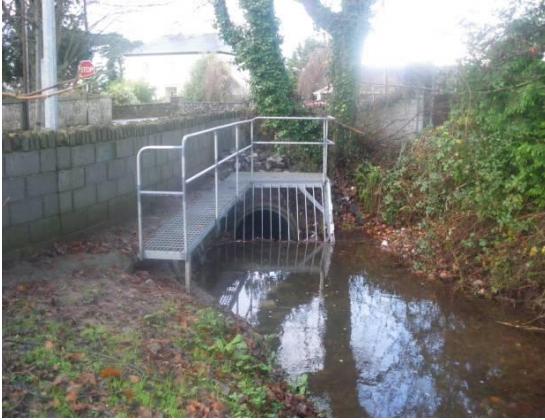
Model Ref. / Location	Description / Photo
WOOD003331 Culvert along Church Road	<p>A circular pipe acts as an inlet to an old stone arch culvert. A section of this old stone culvert collapsed in August 2012 following a period of heavy rain. The repair work included the addition of a trash screen at the inlet.</p>

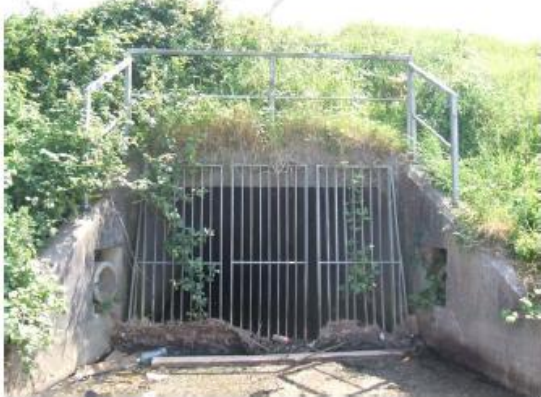
Culvert_9 N25 Road Culvert near GAA grounds

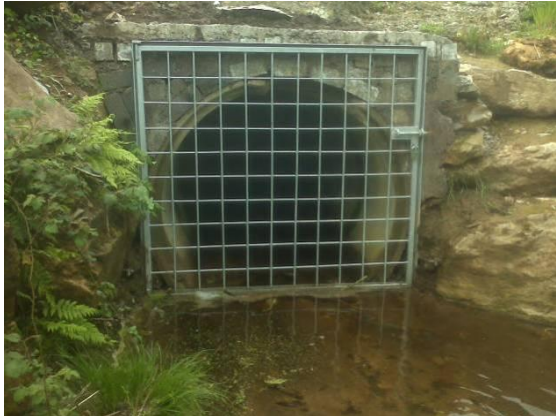
POUL00411 Culvert at Cúl Ard

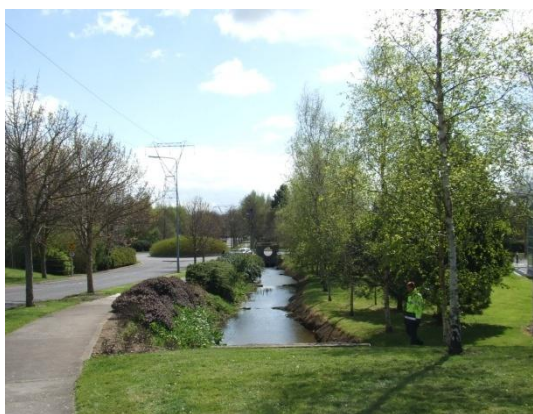
pond / sedimentation area upstream of rail siphon

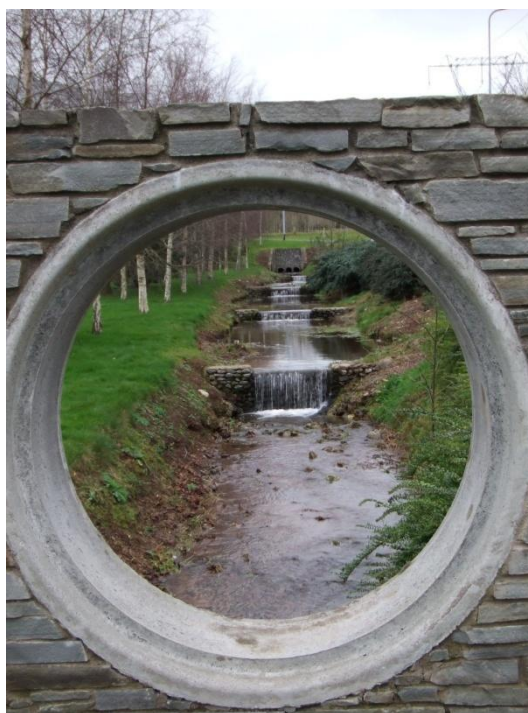
Series of weirs downstream of rail line (looking downstream)

Same series of weirs downstream of rail line (looking upstream)

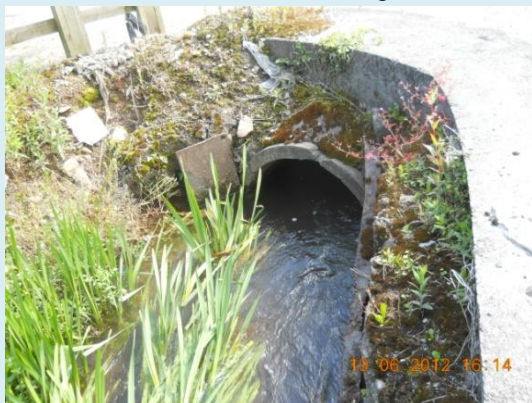
This culvert is located downstream of the sink point at the Irish Rail culvert and while erosion is not an obvious issues at this location, it is noted that the culvert inlet is poorly constructed and flow is not directed into the culvert which could lead to erosion of the bank in high flow conditions. It was also observed on site that there is evidence of localised sedimentation at a potential Fota Retail Park drainage outfall.

Poor culvert inlet

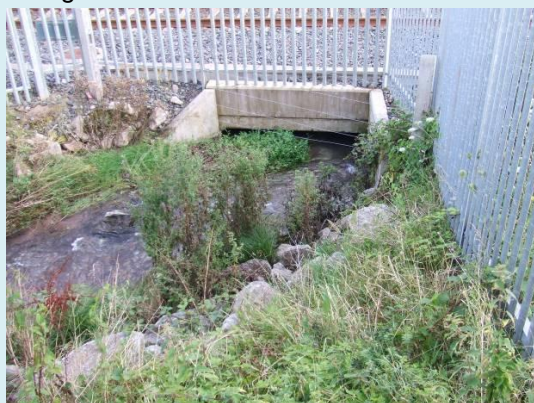
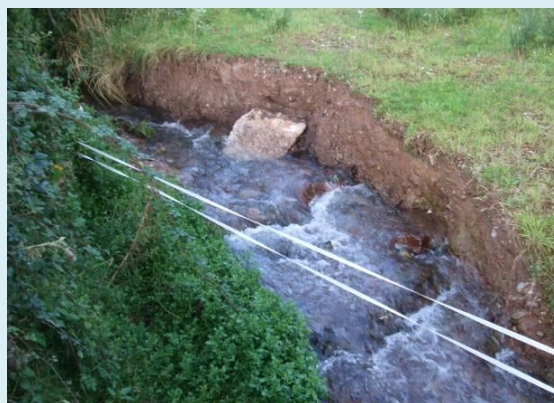
Site visit confirms erosion on the left bank immediately upstream of this culvert. The survey data indicates that the culvert is severely silted with an effective height of 0.36m on the downstream face, whereas the Irish Rail construction drawings indicate that a 1m high culvert with 100mm gravel bed was included for in the design. This demonstrates that there are hydro-geomorphologic factors at play here and the situation should be monitored and managed.

Upstream Face

Evidence of erosion upstream

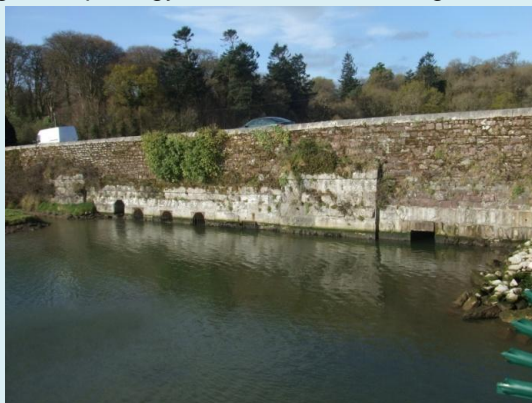
The photos below show the upstream face of the bridge and the second photo illustrates the geomorphology of the channel looking downstream from the pump outfall.

Upstream face of Slatty Bridge

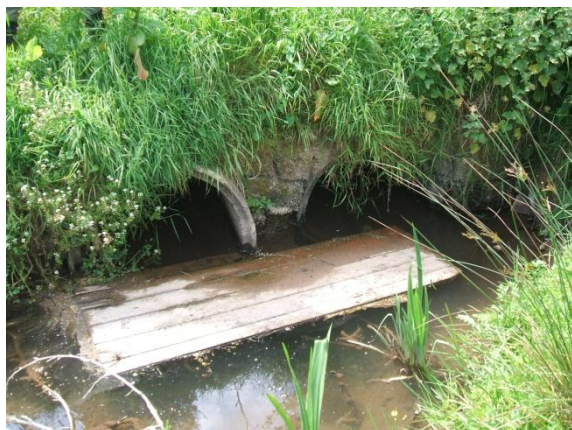
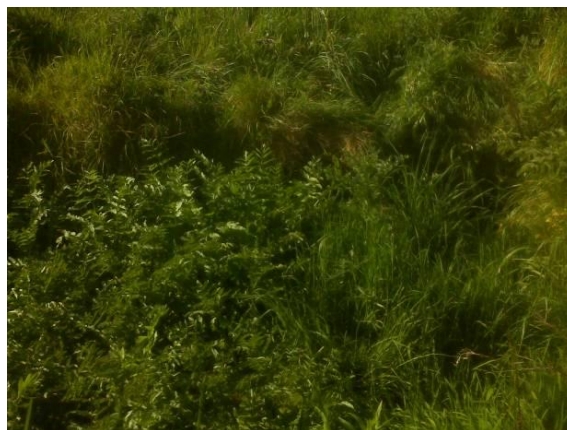
Photo 10-22 Carrigtohill Bridge

June 2007

June 2012

- Carrigtohill Bridge - historically this has been identified as a key structure in terms of flood risk. On site visits it was observed to be heavily vegetated indicating low velocities and sedimentation. This should be monitored to assess the need for regular maintenance works.
